900 MW Fault Induced Solar Photovoltaic Resource Interruption Disturbance Report

Southern California Event: October 9, 2017
Joint NERC and WECC Staff Report

February 2018

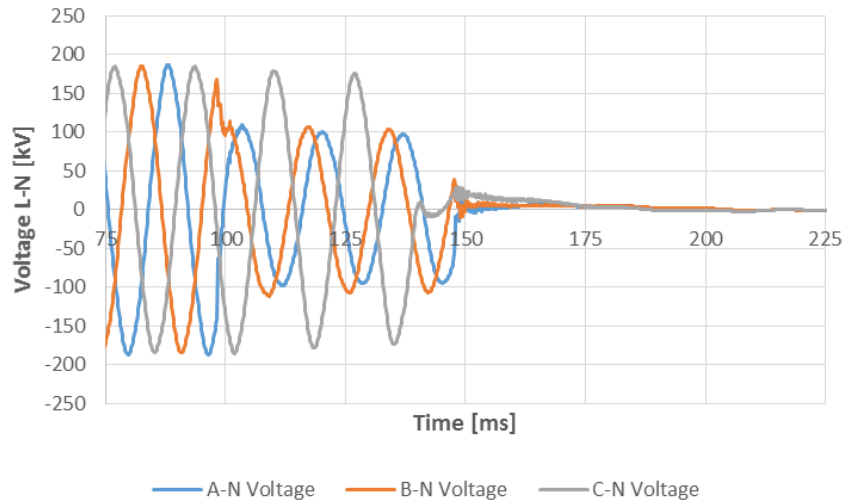
Figure 1.2: DFR Data from 220 kV A-B Phase Fault at 12:12:16 PST [Source: SCE]

Figures 1.2 and 1.3 show digital fault recorder (DFR) point-on-wave data from the fault locations⁸ and demonstrate that both the 220 kV and 500 kV phase-to-phase faults cleared normally with no irregular transient behavior. Both faults resulted in tripping or momentary reduction of a significant amount of solar PV resources affected by these faults. No solar PV generation was de-energized as a direct consequence of the protective relaying removing the faulted element(s) from service; rather, the solar PV inverter controls tripped in response to the measured conditions at their point of measurement (POM) or terminals.

⁸ The 220 kV measurement is on the line side, hence why measured voltage goes to zero upon fault clearing. The 500 kV measurement is on the bus side and measured voltage recovers after fault clearing.

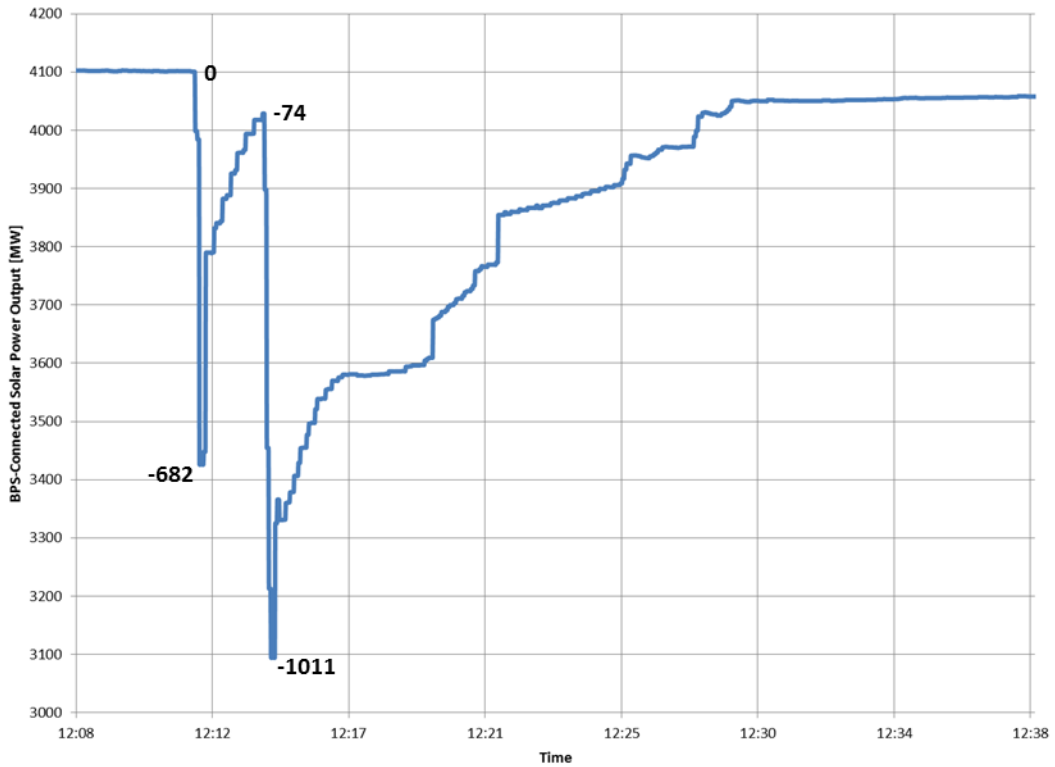
Figure 1.4: Solar PV Response during Canyon 2 Fire [Source: SCE]

The first fault resulted in a reduction of 682 MW of solar PV resources, and the second fault resulted in a reduction of 937 MW. These amounts were determined using supervisory control and data acquisition (SCADA) data supplied by SCE at a resolution of one sample every four seconds. Data of this resolution is able to capture the general response of the solar PV plants over a longer period of time; however, the data cannot differentiate between momentary cessation and tripping in some cases.⁶ Based on data requested for this event (e.g., sequence of events alarms, high resolution measurements, etc.) from Generator Owners (GOs) and Generator Operators (GOPs) for this event, it was confirmed that most of the affected solar PV inverters that did not trip entered momentary cessation. Some plants restored output within five seconds, as recommended in the Blue Cut Fire disturbance report, while others took longer to fully restore power output.

Figure 1.4 shows the aggregate solar PV fleet response during the two events, Figure 1.5 shows the aggregated response of solar PV resources separated by region (to match Figure 1.1), and Figure 1.6 shows the response of the six solar PV plants that accounted for most of the reduction in generation. These plots were generated using SCADA data from Southern California Edison.

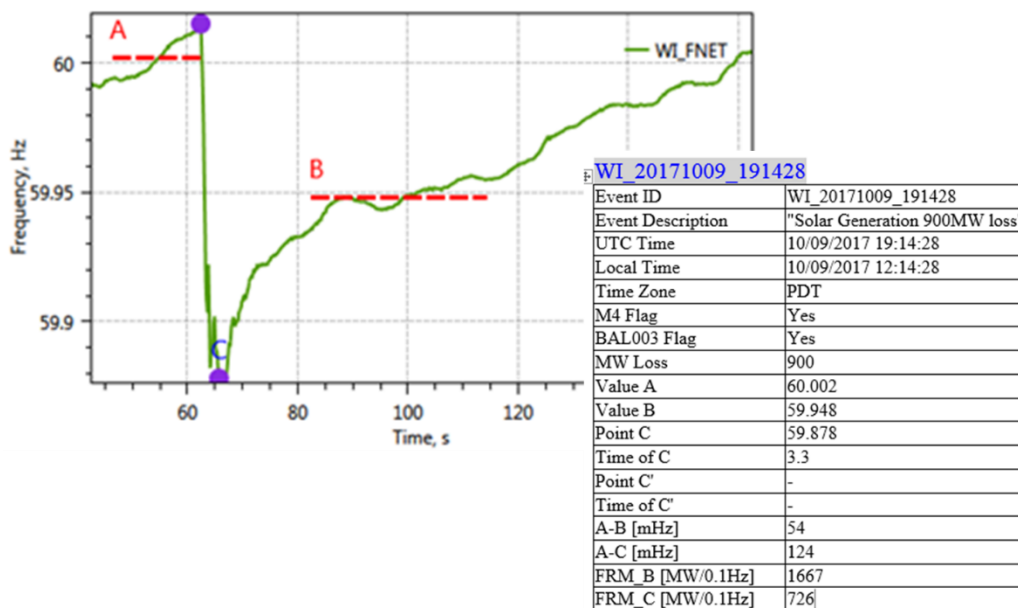
Figure 1.7: Western Interconnection Frequency during Second Fault

The 500 kV fault that resulted in over 900 MW solar PV resource loss caused a frequency excursion in the Western Interconnection with system frequency reaching a frequency nadir of 59.878 Hz about 3.3 seconds after the fault (see Figure 1.7). Frequency recovered to nominal in roughly 100 seconds. The NERC IRPTF is performing stability studies to determine if the momentary loss of inverter-based resources caused by momentary cessation poses any significant risk to frequency stability and if this should be considered in the resource loss protection criteria (RLPC) for the Western Interconnection (i.e., currently the loss of 2 Palo Verde generating units).

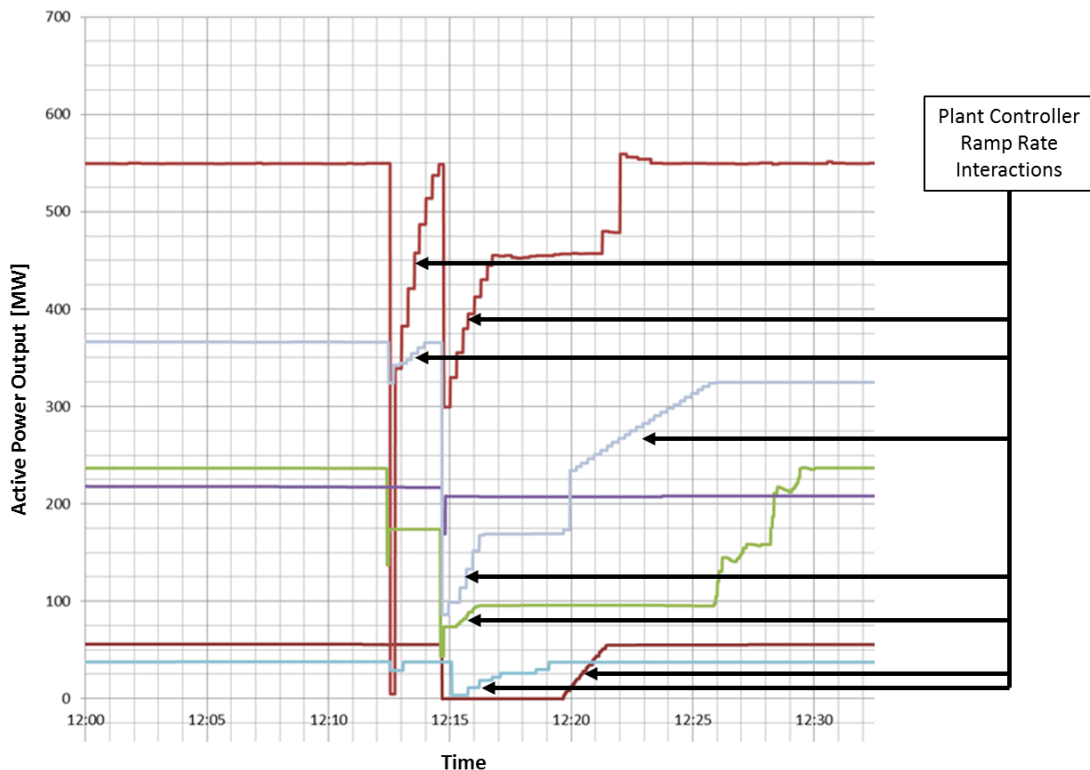
Figure 2.1: Plant Controller Ramp Rate Interactions

During the Canyon 2 Fire disturbance, multiple plants experienced ramp rate limiter interactions that impeded the inverters from recovering to precontingency active current injection quickly. Figure 2.1 shows identified conditions where the plant-level controller imposed ramp rates on the inverters following momentary cessation. This is not the intended operation of inverter-based resources and these interactions following fault conditions need to be remediated to ensure BPS transient and frequency stability (these ramp rates are typically imposed on active power, not reactive power).

Ramp rate limits are typically implemented at the plant-level controller to ensure that the overall plant active power output meets any BA ramping requirements.¹³ This controller is relatively slow, operating around a resolution of 100 ms (10 times per second) or slower. However, when voltage at the plant controller falls below a predetermined level (e.g., 0.9 pu), the plant controller freezes, sending commands based on when the inverters enter ride-through mode or momentary cessation where command values from the plant controller are ignored and each inverter uses its terminal conditions for control. If the inverter enters momentary cessation, it recovers active current injection to predisturbance levels within a programmable amount of time (e.g., within 0.5 seconds). Once voltage recovers to above the predetermined level, the plant controller will again begin sending commands for the inverters to follow. Ramp rates then become controlled by the plant controller again. The plant controller and inverter controls should be coordinated to ensure that active current injection returns to predisturbance levels unimpeded by any interaction with the ramp rate limits of the plant controller.

Inverter-based resources are returning to predisturbance outputs slower than desired because plant-level controller ramp rate limits used for balancing generation and load are being applied to inverter-based resources following momentary cessation. During ride-through conditions, the inverter controls its output and ignores signals sent by the plant-level controller. After voltage recovers and the inverter enters a normal operating range, it again responds to signals from the plant controller. The plant controller then applies its ramp rate limits to the remaining recovery of current injections, restraining the inverter from recovering quickly to its predisturbance current injection.

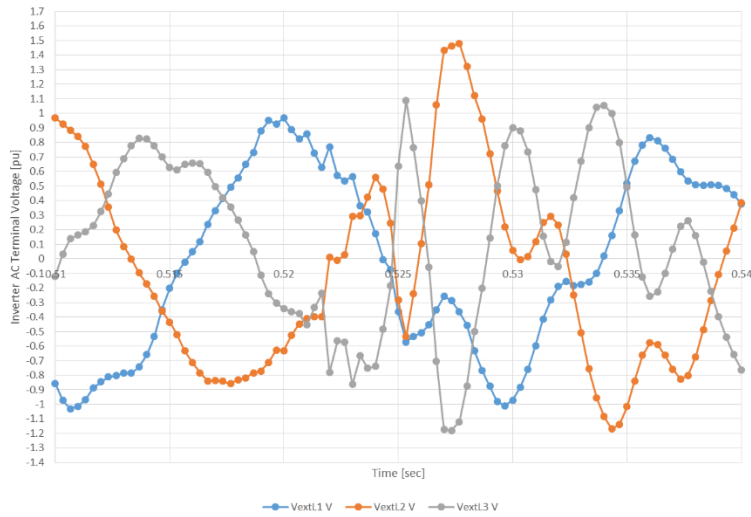
Figure 2.3: Phase Voltages during On-Fault Conditions

In the Canyon 2 Fire disturbance, inverters tripped due to a sub-cycle (less than quarter cycle) measured voltage above the overvoltage protective setting for the inverter (see Figure 2.3¹⁴ and Table 2.2). However, root-mean-square (RMS) trip settings should not be applied to instantaneously sampled voltage measurements. RMS trip settings should be applied to the fundamental frequency component of a filtered ac voltage waveform to avoid spurious tripping on transient overvoltages.

A large percentage of existing inverters on the BPS are configured with instantaneous overvoltage protection at the PRC-024-2 high voltage ride-through curve that does not use any form of filtering. Any instantaneous, sub-cycle transient overvoltage may trip the inverter off-line, making these resources susceptible to tripping on transients caused by faults and other switching actions.

Inverter protective functions should use a filtered, fundamental frequency voltage input for overvoltage protection when compared with the PRC-024-2 ride-through curve. Any sub-cycle transient overvoltage protection, if applicable, should use voltage levels based on equipment limitation that are substantially higher than the PRC-024-2 curve.

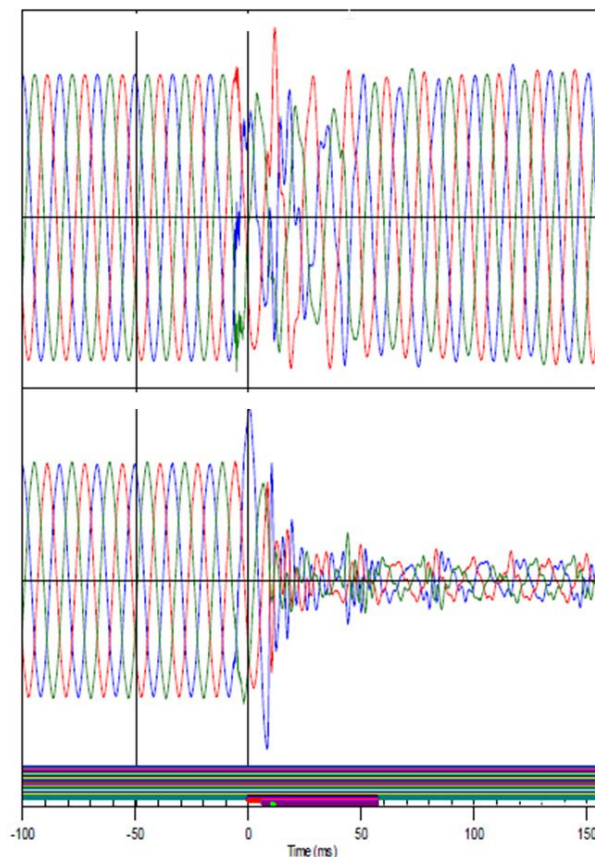
Figure 2.6: DFR Data at Plant POM

inverter-based resource during the Canyon 2 Fire disturbance. The voltage waveform is significantly distorted during the on-fault conditions, and the inverter enters momentary cessation. Historically, inverters have used momentary cessation to ride through the grid disturbance. However, this is not the intended response of inverters since they are expected to ride through these disturbances and continue injecting current to the grid.

This particular solar PV facility entered into momentary cessation during the disturbance and subsequently tripped following fault clearing (as can be seen in the prolonged reduction in current in Figure 2.6) on “ac grid overvoltage” that occurred for less than a single electrical cycle. Plant operator(s) noted that many of the solar PV plants affected by the disturbance have shunt capacitor banks within the plant and that further study is needed to understand the interactions between shunt compensation, momentary cessation, and inverter tripping.

The potential interaction of in-plant shunt capacitors with the response of inverters during and after the fault conditions has been identified in this event as a potential cause for transient overvoltage and warrants further study. Prior to the disturbance, shunt compensation is in-service to support collector system voltages while the inverters are producing active power. When the fault occurs, grid voltages are depressed and most inverters enter into momentary cessation (cease injection of current to the BPS). Upon fault clearing, the inverters take a cycle or two to either ramp back up to predisturbance output or regain synchronism with the grid. During this time, the shunt capacitors are discharging on very low grid voltage. The combination of the inverter momentary cessation and response of the shunt compensation within the plant may be causing a large overshoot in plant voltages for a very short time (less than an electrical cycle). These voltage are not observed at the POM, as reported by TOs for these plants. However, the inverters are observing significantly higher voltage at their terminals, causing them to trip.

the inverter momentary cessation and response of the shunt compensation within the plant may be causing a large overshoot in plant voltages for a very short time (less than an electrical cycle). These voltage are not observed at the POM, as reported by TOs for these plants. However, the inverters are observing significantly higher voltage at their terminals, causing them to trip.

During fault events, there appears to be an interrelationship between momentary cessation, in-plant shunt compensation, and transient overvoltage conditions that result in inverter tripping. While this has been observed at multiple locations for multiple events, the causes and effects are not well understood and require detailed EMT simulations for further investigation.

EMT studies should be performed by the affected GOPs, in coordination with their TO(s), to better understand the cause of transient overvoltages resulting in inverter tripping. These studies should also identify why the observed inverter terminal voltages are much higher than the voltage at the point of measurement (POM), and any protection coordination needed to ride through these types of voltage conditions.
