900 MW Fault Induced Solar Photovoltaic Resource Interruption Disturbance Report

Southern California Event: October 9, 2017
Joint NERC and WECC Staff Report

February 2018

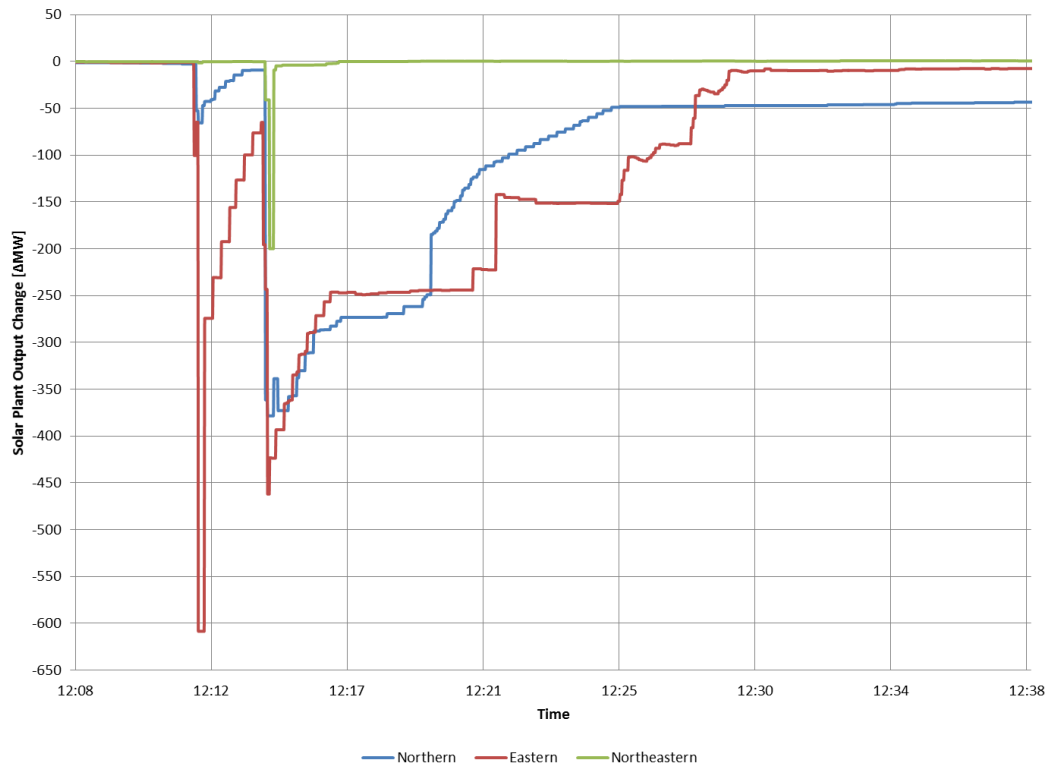
Figure 1.5: Regional Solar PV Response during Canyon 2 Fire [Source: SCE]

Figure 1.4 shows the aggregate solar PV fleet response during the two events, Figure 1.5 shows the aggregated response of solar PV resources separated by region (to match Figure 1.1), and Figure 1.6 shows the response of the six solar PV plants that accounted for most of the reduction in generation. These plots were generated using SCADA data from Southern California Edison.

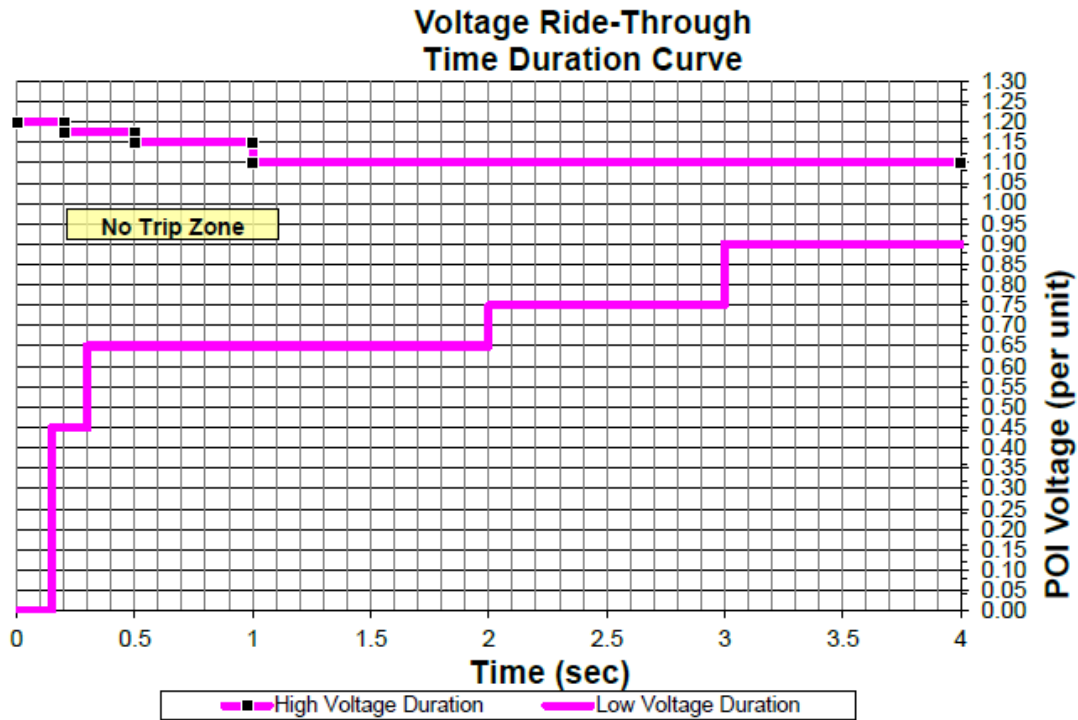
Figure 2.2: PRC-024-2 Voltage Ride-Through Curve

All responses from the data request sent after the October 9, 2017, disturbance indicated that the PRC-024-2 voltage ride-through curve (see Figure 2.2 and Table 2.1) was used to set the voltage protective relay settings for inverters installed on the BPS. Some responses also indicated that the “may trip” zone is still interpreted as a “must trip” zone, despite the attempt in the Blue Cut Fire disturbance report to clarify the intent of PRC-024-2.

The PRC-024-2 ride-through curve is often used as the inverter voltage protection trip settings by default rather than considering equipment limitations to set the protective thresholds. The intent of the PRC-024-2 curve is not to specify a design criteria for resources. Rather, inverter protection settings should be based on the equipment specifications that may be wider than those of the PRC-024-2 curve. The IRPTF is investigating in simulations the potential impacts of all inverters in a geographical or electrical region tripping during voltage transients.

The intent of PRC-024-2 is to define the minimum and maximum voltage conditions where generating resources may trip for voltage excursions. The region outside the “no trip” zone should be interpreted as a “may trip” zone and not a “must trip” zone. Inverter settings should be determined based on equipment limitations and should be set to ride-through to the greatest extent possible. This helps support BPS reliability during and following grid events such as faults.

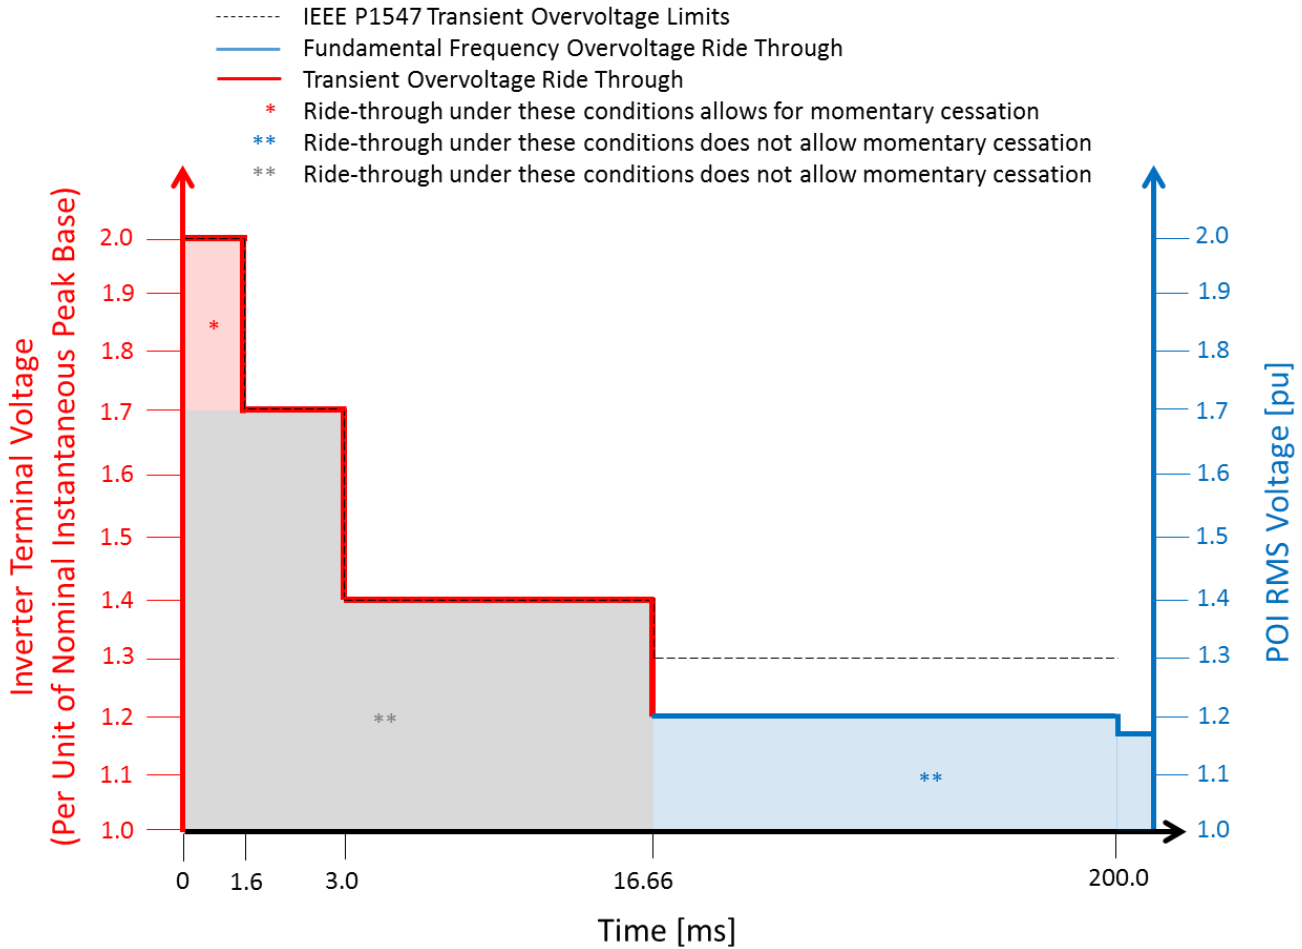
Figure 2.4: Recommended Overvoltage Ride-Through Curve

The NERC IRPTF has drafted the recommended transient overvoltage ride-through curve shown in Figure 2.4. Further details will be provided in the Reliability Guideline under development by the IRPTF. This curve differentiates between sub-cycle overvoltage that uses an instantaneously measured ac voltage value and RMS overvoltage that should use a well filtered, fundamental frequency RMS voltage measurement. The overvoltage ride-through limits on the RMS portion of the curve mirror PRC-024-2 while the limits on the sub-cycle instantaneous portion of the curve are based on new technology inverter capabilities, historical overvoltage events, known equipment limitations, and simulations of potential overvoltage conditions that can be expected at inverters on the BPS. Note that the RMS portion of the waveform applies to the POI of the inverter-based resources while the sub-cycle portion is a recommended specification for the inverters themselves.

Inverter protective functions should use a filtered, fundamental frequency voltage input for overvoltage protection when compared with the PRC-024-2 ride-through curve. Any sub-cycle transient overvoltage protection, if applicable, should use voltage levels based on equipment limitation that are substantially higher than the PRC-024-2 curve.

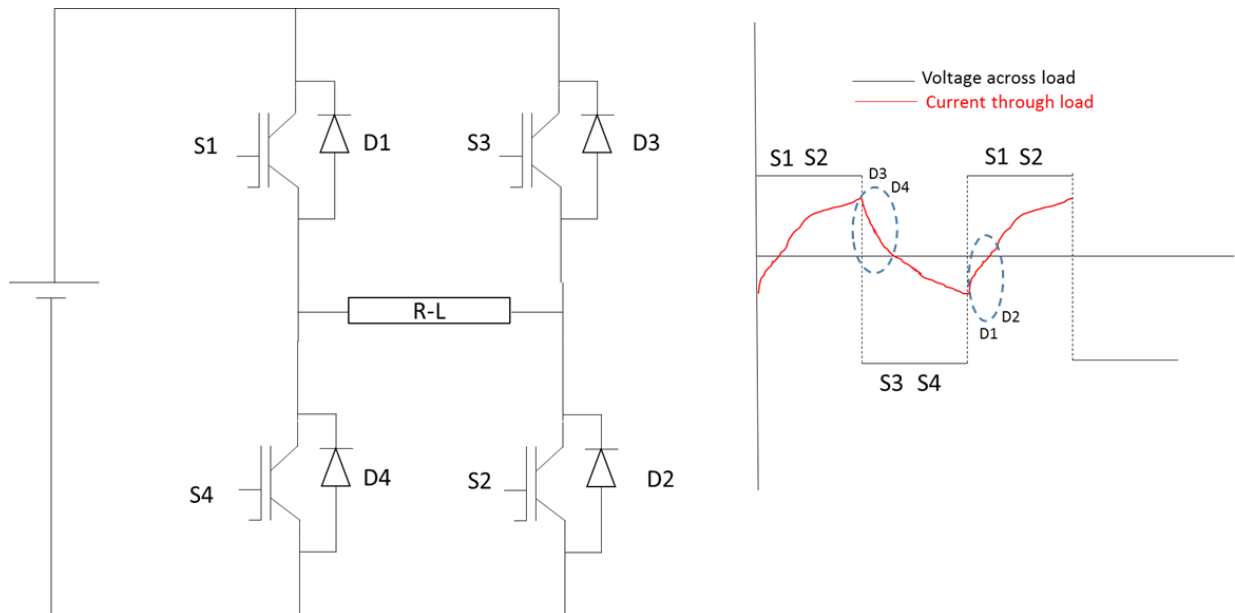
Figure 2.5: Online Illustration of Anti-Parallel Diodes

One inverter manufacturer reported fault codes for dc reverse current, where protective action opened the inverter primary circuit breaker. The dc reverse current is considered a “major fault” by that manufacturer that requires a manual reset at the inverter. This resulted in the resources remaining off-line for an average of 81 minutes after tripping.

Inverters have anti-parallel diodes across the insulated-gate bipolar transistors (IGBTs), or switches in the power electronics (see illustration in Figure 2.5), to mitigate voltage spikes during switching. For inductive loads, like loads across the BPS, current through the inductor cannot change instantly otherwise transient voltage spikes occur. The anti-parallel diodes are used to allow current through the inductive load to go to zero. For example, when switches S1 and S2 are on, current flows left to right in the R-L load. When the half cycle is over, S1 and S2 turn off and S3 and S4 turn on. During this time, energy is fed back to the dc bus. During normal operation, this is a small amount of reverse current and is acceptable. During normal operation, the inverter is generating an ac waveform from the dc voltage through IGBT gating. This process necessitates the inverter to balance the ac voltage so as to keep the potential higher on the dc side. Normally this is not a problem; the maximum ac voltage the inverter can generate is sufficiently lower than the field dc voltage, thus current can flow out to the grid. However, ac transient over-voltages may cause the ac voltage to be greater than the dc voltage. This can lead to current flowing into the dc bus and PV arrays.

GOs should coordinate with their inverter manufacturers to ensure that dc reverse current detection and protection are set to avoid tripping for dc reverse currents that could result during sub-cycle transient overvoltage conditions since these are not likely to damage any equipment in the plant. Mitigating steps may include increasing the magnitude settings to align with the ratings of the equipment or implementing a short duration to the dc reverse current protection before sending the trip command.
